123 MAIN ST. SUNNY DAY, PA 12345

# Visual Property Inspection

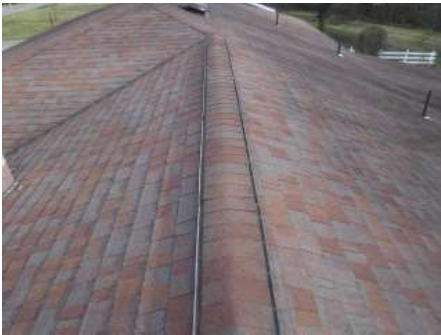
## Roof System Photos

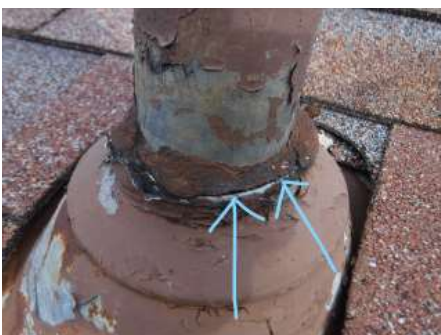
Mast Boot Flashing - Gaps/deteriorated sealant - Needs sealed

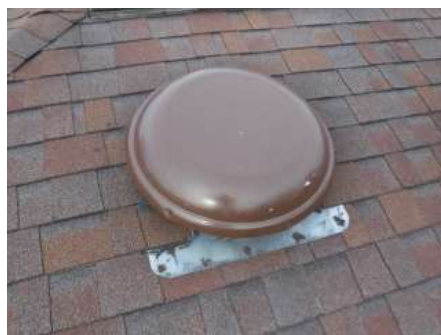
Power Roof/Attic Fan Picture

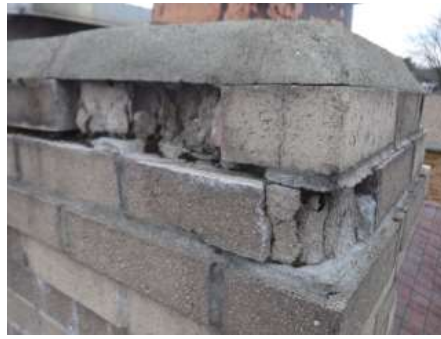
There are a few deteriorating/spalling bricks on the chimney

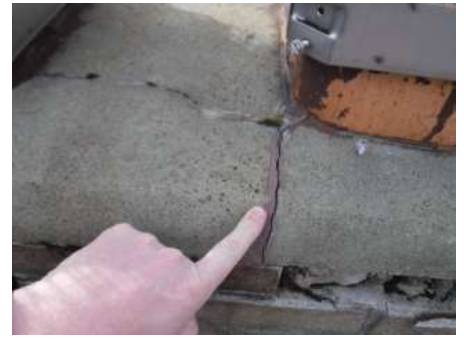
There are a few cracks in the topside of the chimney crown mortar

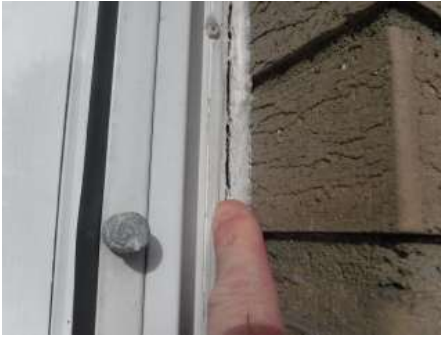
Gaps in the window flashing's - Needs re-caulked

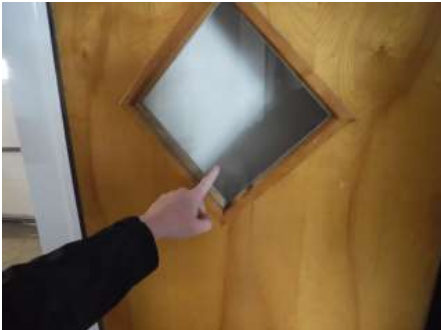
Garage man door is not fire rated

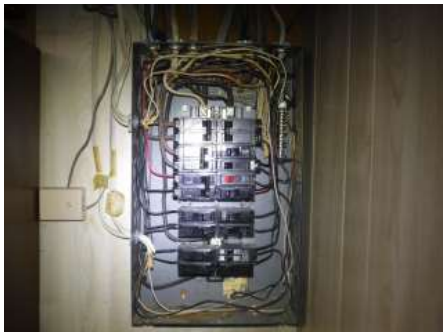
## Electrical Service Photos

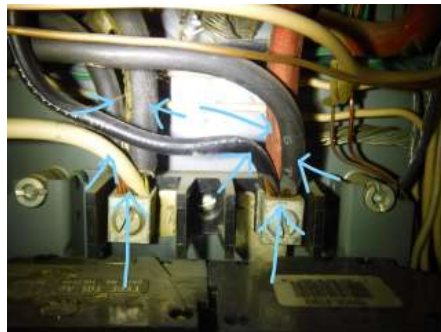
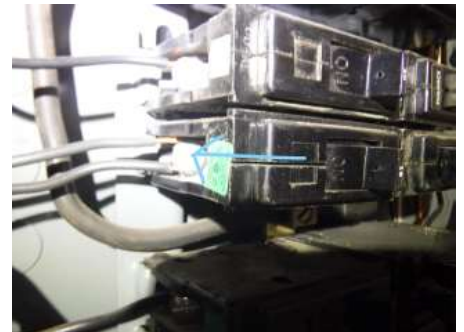
The main lugs have been improperly triple lugged in the main electric panel

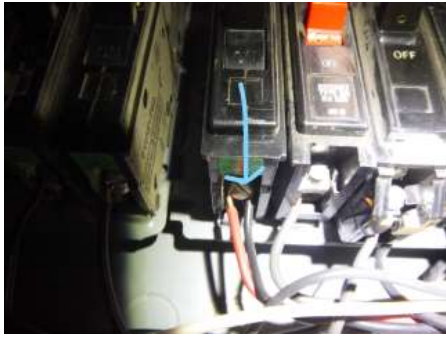
Double lug/tap breaker connection in main electric panel

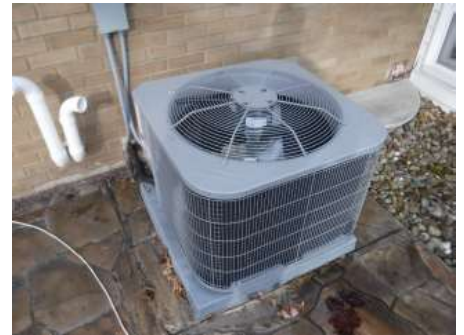
Air Conditioner Picture

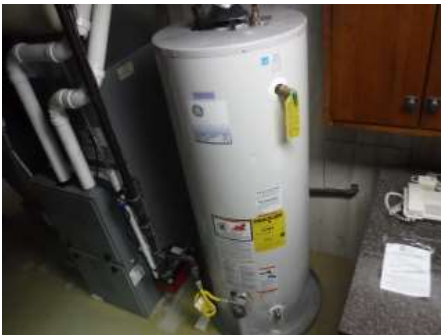
Water Tank Picture - Improper Draft/Back Drafting

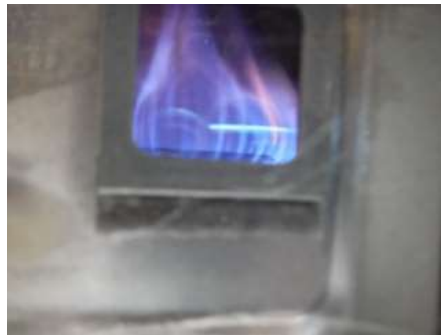
Water Tank Flames Picture

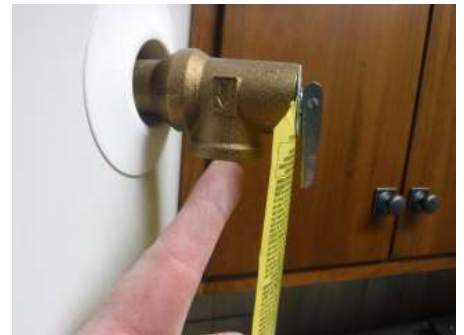
Missing down tube on the TPR valve

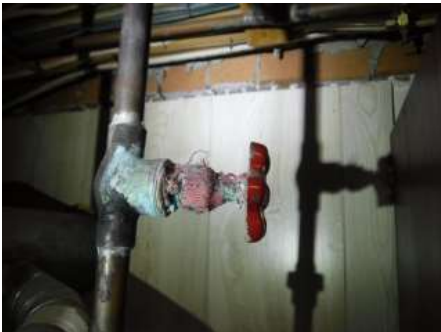
Corrosion on water tank shut-off valve from it previously leaking. No signs of any active leaking at time of inspection

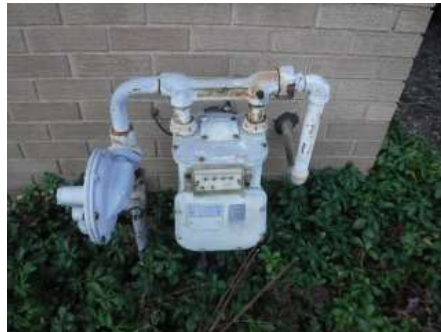
Gas Meter / Main Gas Shut-Off Valve Location

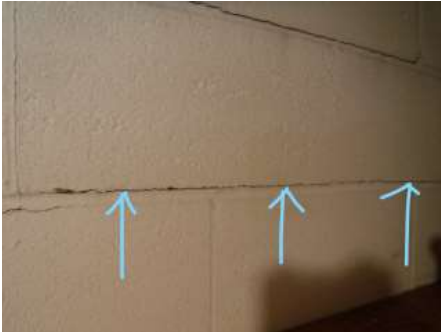
Minor horizontal crack in the front side basement wall

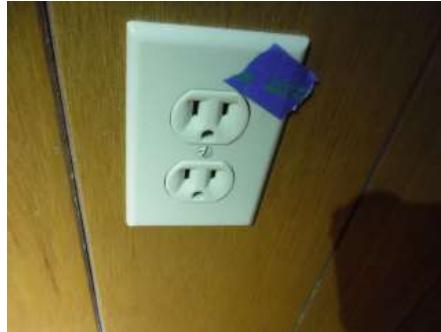
Some open grounds on receptacles in the basement

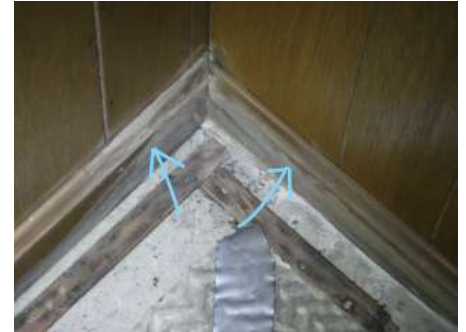
Signs of previous water wicking/staining at the bottom of the wall paneling/trim

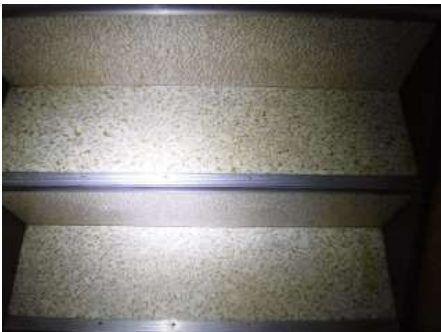
The linoleum/vinyl flooring on basement steps may contain asbestos

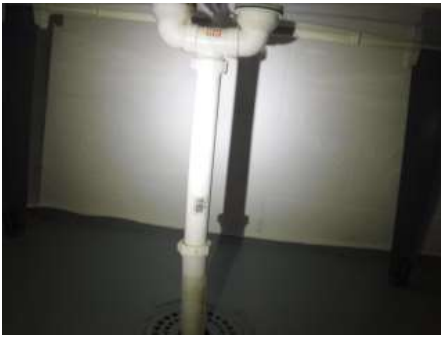
Utility sink drain is missing a trap to prevent sewer gas/smell from entering the home

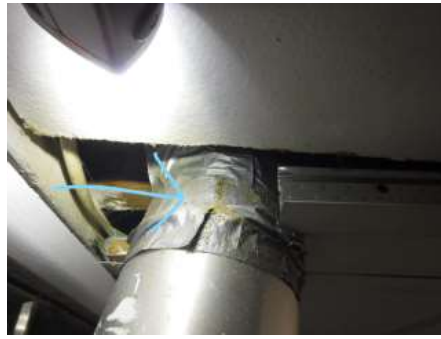
(Fire Hazard) - Improper use of duck tape on dryer exhaust ducting. Duck tape has the potential to catch on fire

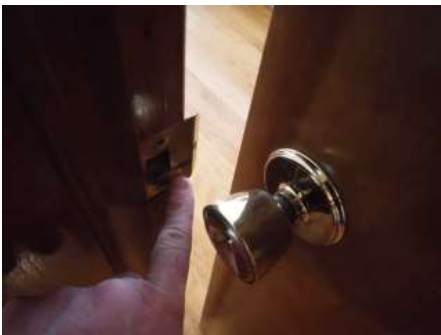
Master & Front Middle Bedroom - The door does not latch/close

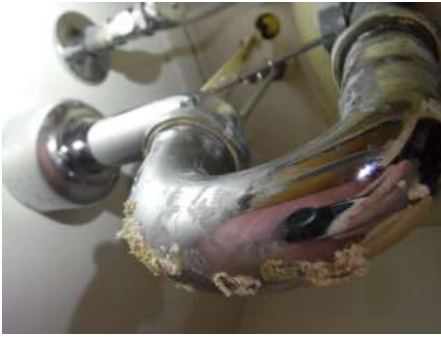
Master Bathroom - The sink drain is corroded

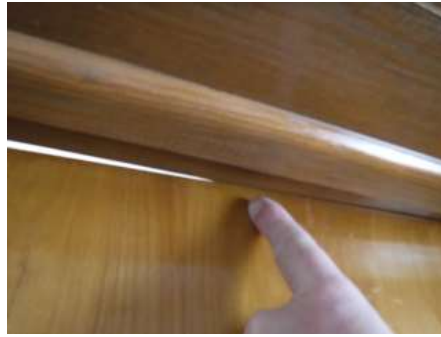
Master Bathroom - The door rub/sticks on the door frame

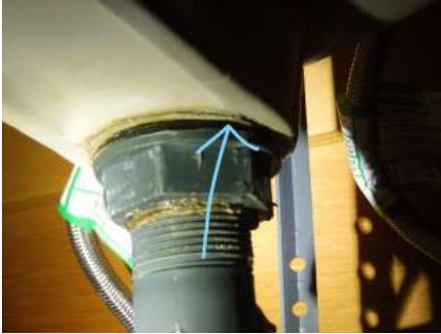
Main Bathroom - Sink drain is leaking at the sink bowl connection

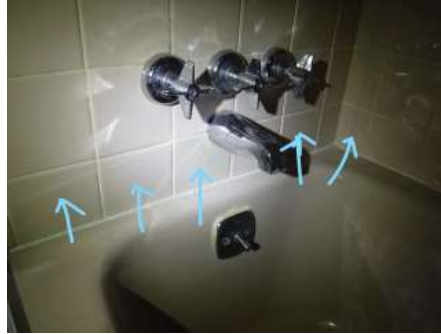
Main Bathroom - The lower row of tiles do not appear to be fully adhered to the wall surface

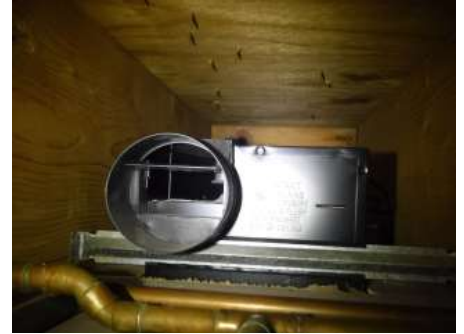
Basement Bathroom - The exhaust vent is improperly discharging above the drop ceiling

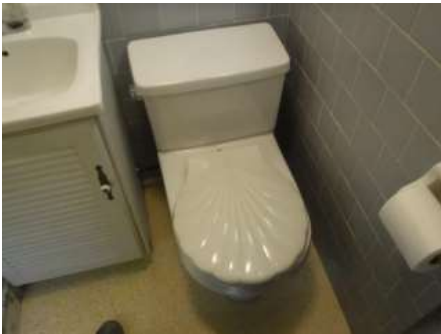
Master & Basement Bathroom - The toilets are loose from the floor

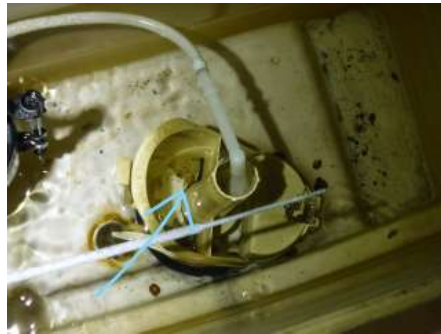
Basement Bathroom - The flapper inside the holding tank does not function properly, you have to hold down the flush handle the whole time until the toilet has fully flushed
